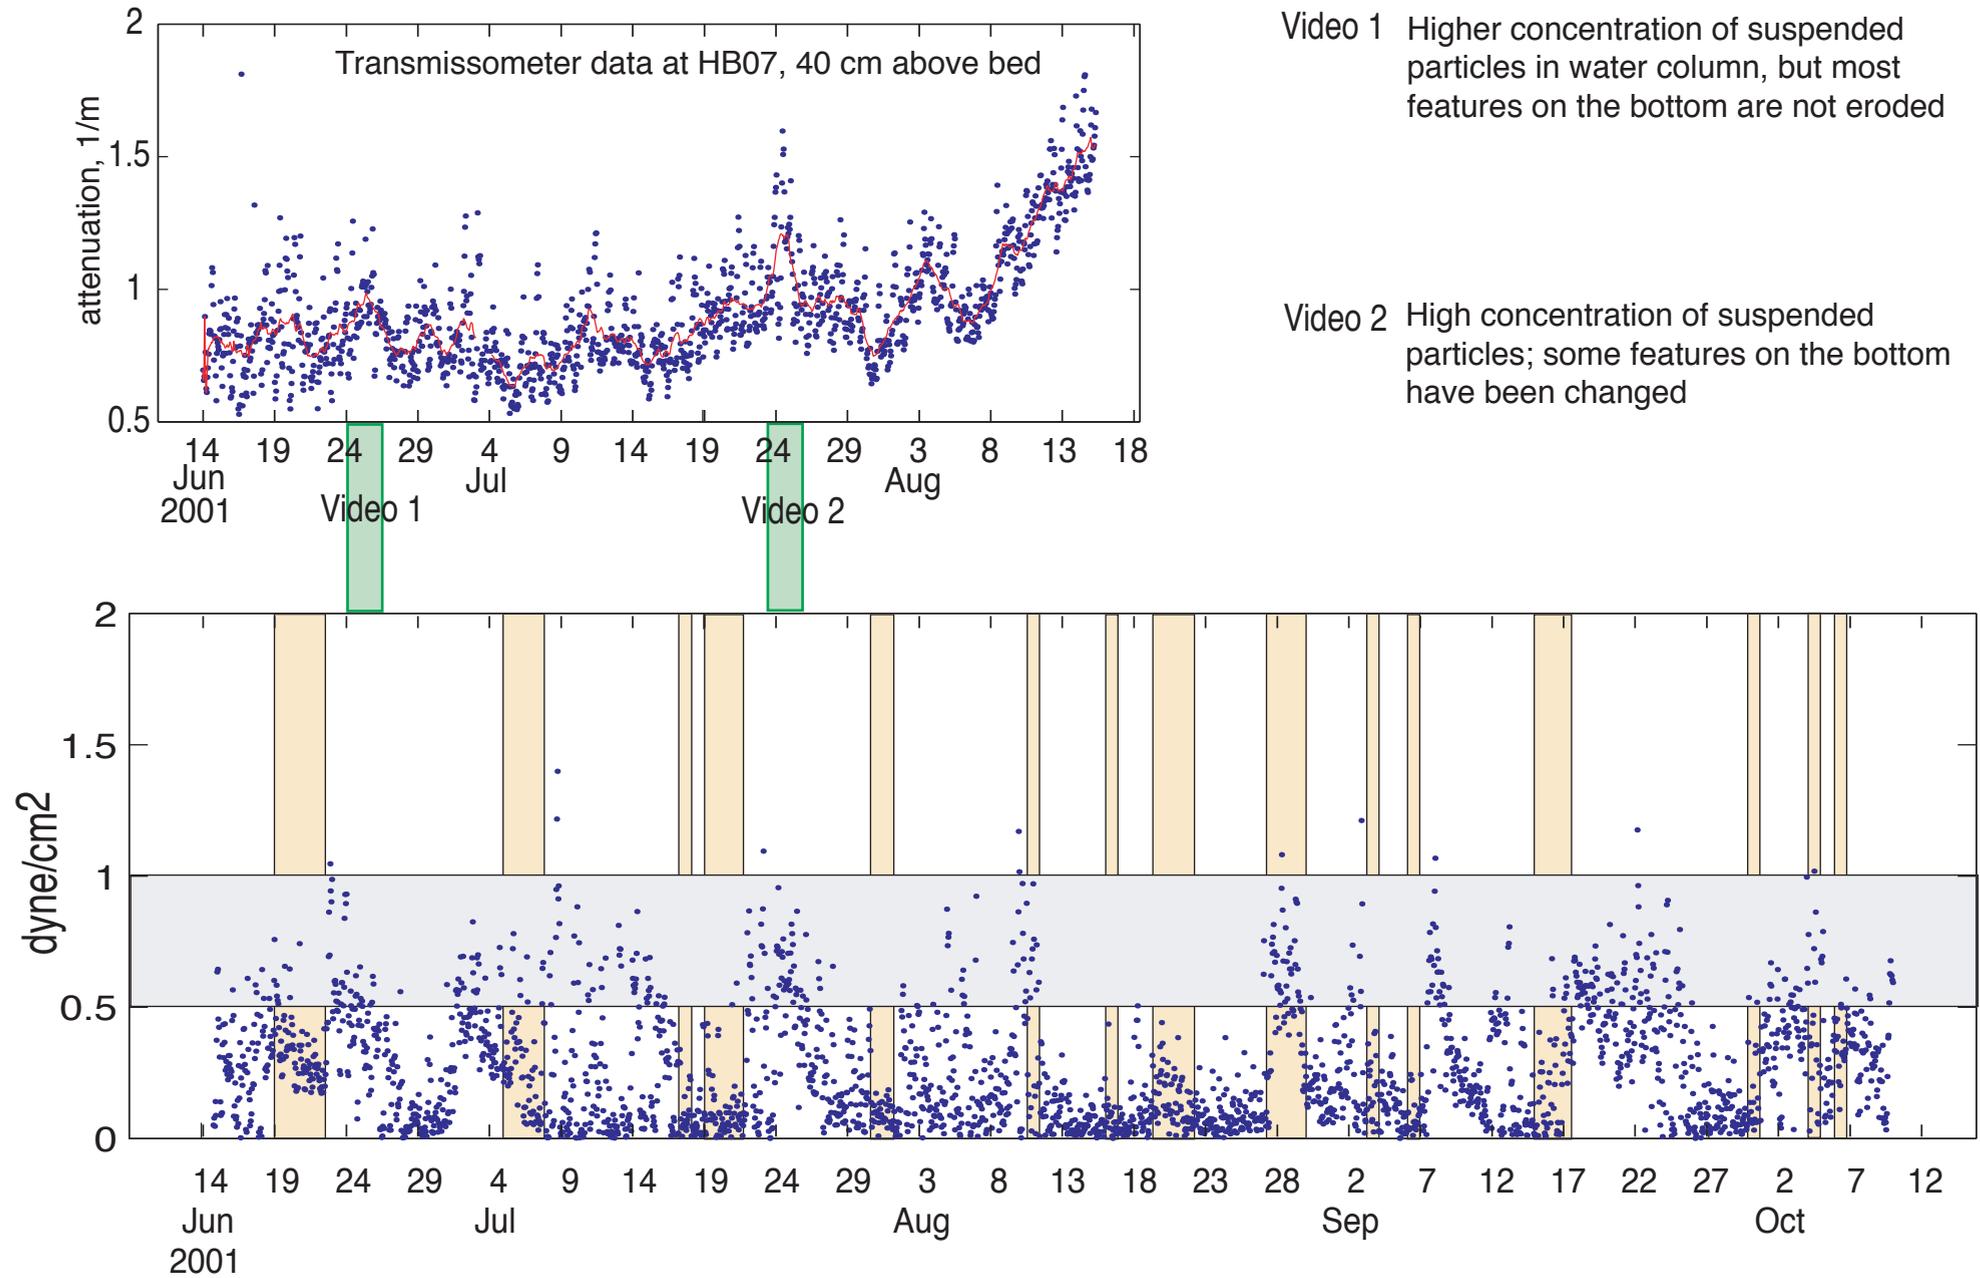
Figure 8-7. Time-series of water clarity (top panel, red line is low-pass-filtered) and estimated bed shear stress (bottom panel). The transmissometer was fouled after early August. The vertical bands in the bottom panel designate the beach contamination events. Shear stress values within or above the horizontal band are able to resuspend very fine sands and silts.
